Title: Wastewater Treatment Plant and Fire Roofs

Management Report

City of Delano
Sewer Plant
800 River Street North, Delano, MN

City of Delano
Delano Fire Station
245 2nd Street North, Delano, MN

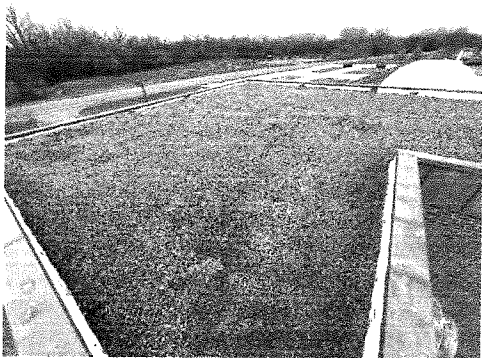
General - (Emergency)

Based on the current condition of the roof, it is recommended that the owner respond to roof leaks as they occur until a full roof replacement can be completed. In our opinion, additional maintenance efforts will not significantly extend the remaining service life of the existing roof system

Replace the roof as budget allows. The existing roof system has reached the end of its serviceable life, and replacement will provide the most effective long-term solution for maintaining building integrity and performance.

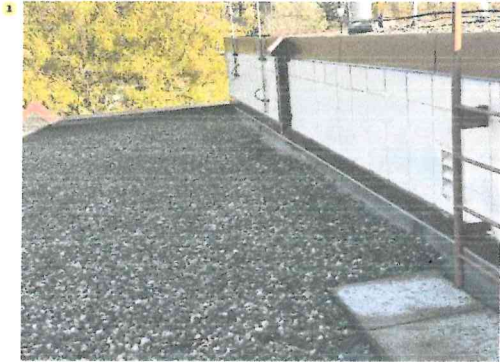
General - Tenting (Emergency)

Tenting of the membrane is caused by the overall shrinking that takes place over time. The shrinking of the membrane causing it to pull away from perimeter walls and cause stress of the flashing areas of the roof.

The existing membrane would need to be cut and allowed to relax and a new piece of flashing membrane spliced in to ensure a water tight seal.
