Title: Wastewater Treatment Plant and Fire Roofs

Management Report

City of Delano
Sewer Plant
800 River Street North, Delano, MN

City of Delano
Delano Fire Station
245 2nd Street North, Delano, MN

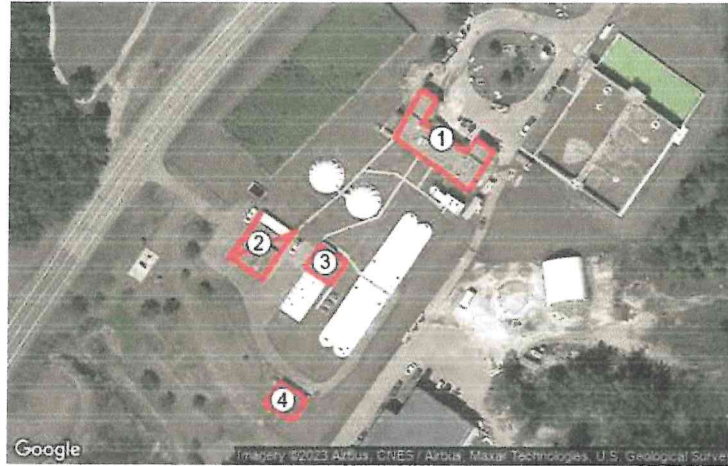
Total Sections: 4
Total Sq Ft: 7,939

Map	Name	Sq Ft	Est Install	Grade
1	Section 1	4,434		B
2	Section 2	1,384		F
3	Section 3	1,046		F
4	Section 4	1,076		F

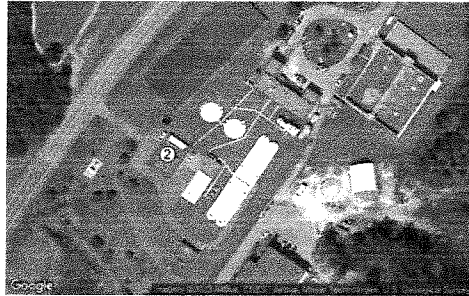
Section: Section 2
Size: 1384
Overall Grade: F

Membrane: F
Flashings: F
Sheet Metal: D

Overall: F

This roof is in poor condition and should be scheduled for a replacement as soon as possible

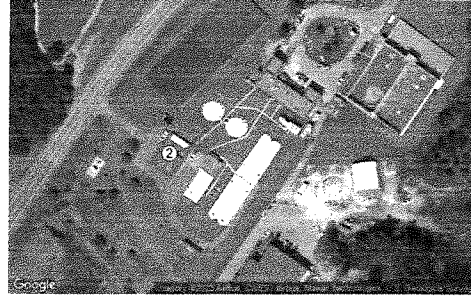
2 - Section 2 (1,384 Sq Ft) Grade F

Based on the current condition...

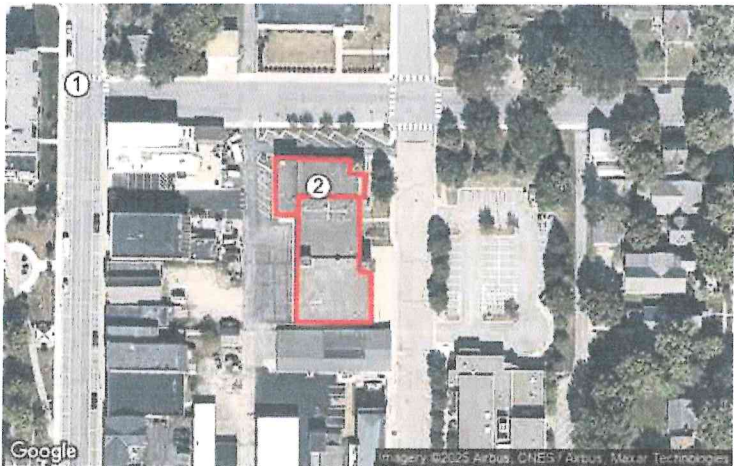
Total Sections: 2
Total Sq Ft: 15,262

Map	Name	Sq Ft	Est Install	Grade
1	Section 1	10,689	2024	A
2	Section 2	4,573		D

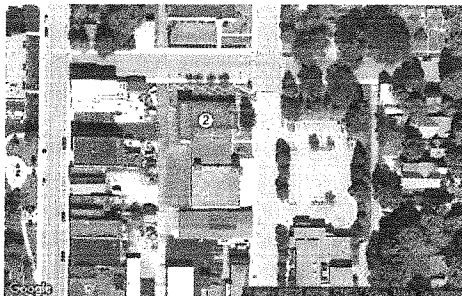
Section: Section 2
Size: 4573
Overall Grade: D

Membrane: D
Flashings: D
Sheet Metal: D

Based on the observed condition of the existing roof system, it is recommended that the owner undertake an aggressive maintenance program to extend the serviceable life of the roof by an estimated three to five years. All deficiencies should be addressed promptly, and repairs or component replacements should be performed as necessary to maintain watertight integrity and overall performance.
